**Flood Control Project Maintenance  
Levee Inspections**

**Fall 2018 Levee Maintenance Deficiency Summary Report**

**Sacramento River Basin**

**Sacramento Maintenance Yard Putah Creek**

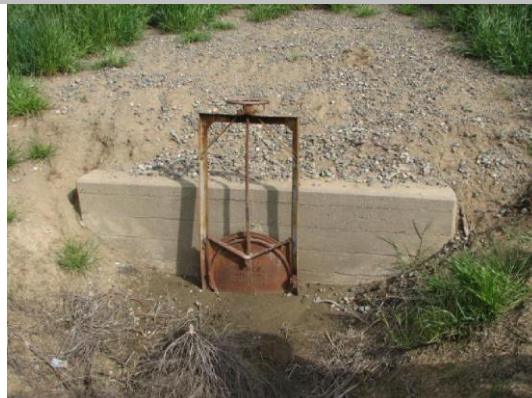
Photo 1 of 3 : UCIP\_FA\_2018\_33408\_60493.jpg

LM Start	<b>0.58</b>	Rating **	A/W	Issue No.	<b>57</b>
LM End	<b>0.58</b>	Issue Type +	Ma	Location *	
Category	Supplemental			GPS Latitude/Longitude	
				Start	End
Item	DWR UCIP LMA Responsibility			38.519660 °	38.519660 °
				-121.638820 °	-121.638820 °
DWR ID	488				
Comment Code					
Inspector Comment					
FS_ID:33408 DS_ID:488 EP_NO: 10261 Repair Type: No Action Needed Crossing Status: Found UCIP Comments: FIELD_STRUCT_DESC: 24-inch drainage pipe of unknown material through the levee, 12.5 feet below the crown. Slide gate is located on the waterside (WS) end. Concrete headwall is located on the WS. (24-inch pipe [HLM 0.58] authorized under Automatic Board Order (ABO) issued as Permit No. 10261, 1974 - Tufts) [Additional Reference(s): DWR Levee Log, 1981 and 2005. USACE Sacramento O&M Manual Unit 119, December 1952, (Station XX+XX)] FS Date: 4/10/2014 2:49:52 PM

WS slide gate and headwall

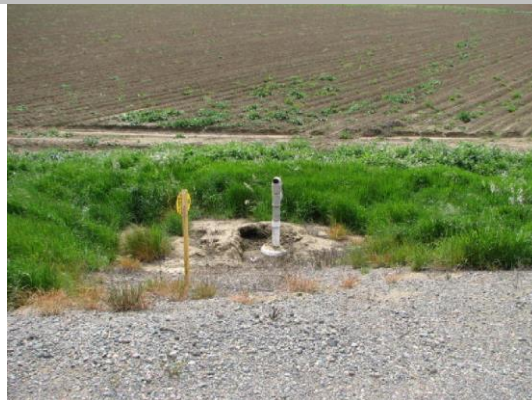
Photo 1 of 3 : UCIP\_FA\_2018\_48122\_60481.jpg

Comment Code						
Inspector Comment						
FS_ID:48122 DS_ID:489 EP_NO: 10262 Repair Type: Non-Urgent Crossing Status: Found UCIP Comments: Pump is disconnected from pipe and could cause backflow at highwater event. Can't see size of pipe sleeved through 24-inch pipe. FIELD_STRUCT_DESC: 18-inch steel irrigation pipe (field verified not 16-inch) sleeved through existing 24-inch drainage steel pipe through levee, 12.5 feet below the crown. Annular space sealed at both the waterside (WS) and landside (LS) ends. Concrete headwalls are located on both the WS and LS ends. PVC sleeved December of 2007 (unknown source). (16-inch pipe sleeved through 24-inch pipe authorized under Automatic Board Order (ABO) issued as Permit No. 10262, 1974 - Wells Fargo Bank, Trustee for S.H. Cowell Foundation) [Additional Reference(s): DWR Levee Log, March 2007. USACE Sacramento O&M Manual 119, December 1952] FS Date: 4/10/2014 2:48:00 PM

WS vent

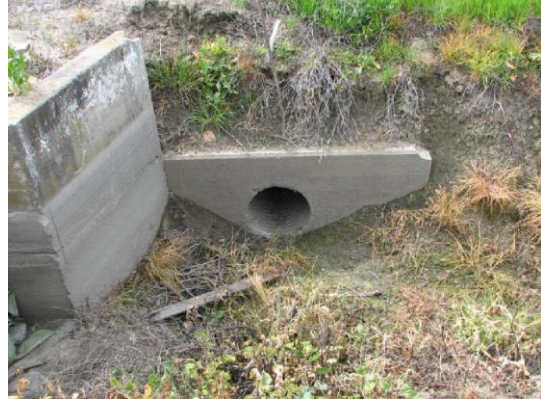
Photo 1 of 3 : UCIP\_FA\_2018\_43033\_60465.jpg

Comment Code					
Inspector Comment					
FS_ID:43033 DS_ID:491 EP_NO: 10262 Repair Type: Non-Urgent Crossing Status: Found UCIP Comments: 09/21/2017 Pipe was permitted as an irrigation structure under ABO issued as Permit No. 10262. (DWR UCIP - O. Magana) 04/03/2012 Pipe has significant rust and exfoliation of metal showing at ends. Reccomend video inspection. (DWR UCIP - W. Wylie) FIELD_STRUCT_DESC: 24-inch irrigation pipe of unknown material through levee, 15.5 feet below crown. Slide gate is located on the waterside (WS) end. Concrete headwall is located on the landside (LS) end. (24-inch pipe [HLM 2.17] authorized under Automatic Board Order (ABO) issued as Permit No. 10262, 1974 - Wells Fargo Bank, Trustee for S.H. Cowell Foundation) [Additional Reference(s): DWR Levee Log, 1981 and 2005. USACE Sacramento O&M Manual Unit 119, December 1952, (Station XX+XX)] FS Date: 4/10/2014 2:45:00 PM

LS headwall

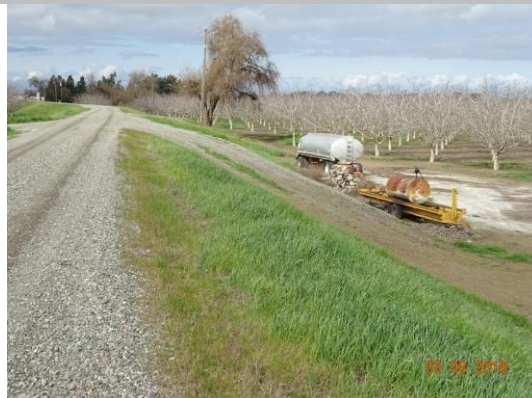
Photo 1 of 1 : FA\_2018\_ST0007\_282\_35\_20180925\_00005.jpg

LM Start	3.05	Rating **	M	Issue No.	35
LM End	3.05	Issue Type +	En	Location *	LS
Category	Earthen Levee			GPS Latitude/Longitude	
				Start	End
Item	Encroachments			38.519205 °	38.519205 °
				-121.682618 °	-121.682618 °
DWR ID	DWR_ST0007_01_s_2018_35				
Comment Code					
EQ : Equipment					
Inspector Comment					
Ag equipment and cut wood pile should be removed from LS toe to allow inspection and access.

Ag equipment and wood pile at levee toe should be removed to allow inspection and access.

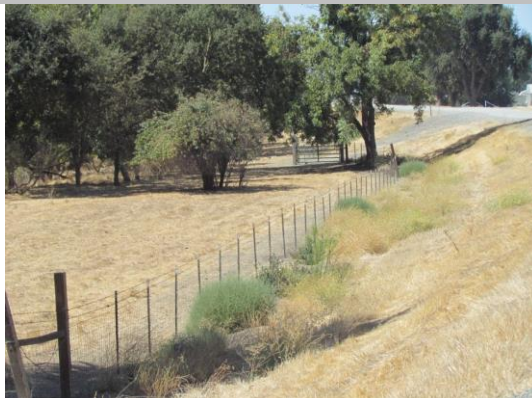
Photo 1 of 1 : FA\_2018\_ST0007\_282\_4\_20180925\_00001.jpg

LM Start	3.25	Rating **	M	Issue No.	4
LM End	3.64	Issue Type +	En	Location *	WS
Category	Earthen Levee			GPS Latitude/Longitude	
				Start	End
Item	Encroachments			38.519831 °	38.519848 °
				-121.686263 °	-121.693463 °
DWR ID	DWR_ST0007_01_s_2013_4				
Comment Code					
FE : Fence					
Inspector Comment					
No permit for this wire fence waterside levee slope.

Wire fence within the 10-foot easement waterside levee toe.

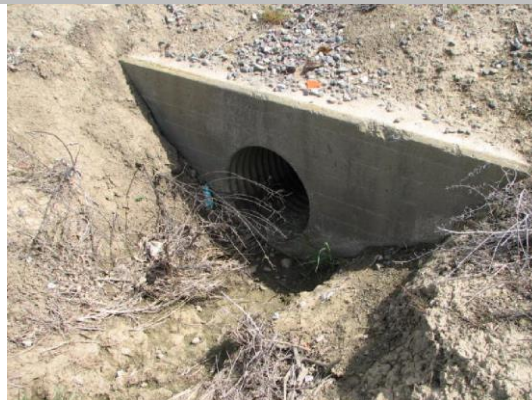
Photo 2 of 3 : UCIP\_FA\_2018\_33381\_60441.jpg

Comment Code						
Inspector Comment						
FS_ID:33381						
DS_ID:496						
EP_NO: 10251						
Repair Type: No Action Needed						
Crossing Status: Found						
UCIP Comments:						
FIELD_STRUCT_DESC: 24-inch corrugated metal drainage pipe through levee, 15 feet below the crown. Two metal cutoff walls were installed through the levee. A T-post and T-handle are located on the landside (LS) toe. The outfall structure and flap gate are located on the west side of bridge, waterside (WS). (24-inch pipe [HLM 3.87] authorized under Automatic Board Order (ABO) issued as Permit No. 10251, 1974 - F.M.C. Corp.) [Additional Reference(s): DWR Levee Log, 1981 and 2005. USACE Sacramento O&M Manual Unit 119, December 1952, (Station XX+XX)]						
FS Date: 4/10/2014 2:40:30 PM

LS headwall and pipe

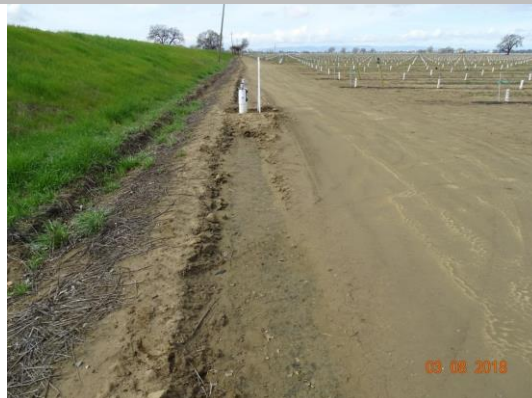
Photo 2 of 2 : FA\_2018\_ST0007\_282\_39\_20180925\_00009.jpg

LM Start	4.32	Rating **	M	Issue No.	39 (cont)	
LM End	4.80	Issue Type +	En	Location *	LS	
Category	Earthen Levee			GPS Latitude/Longitude		
				Start		End
Item	Encroachments			38.518280 °	38.518041 °	
				-121.704657 °	-121.713680 °	
DWR ID	DWR_ST0007_01_s_2018_39					
Comment Code						
PI : Pipe						
Inspector Comment						
Newly planted orchard on LS appears to have installed a water pipe with visible risers parallel to levee approx 8 feet from toe. This pipe should be verified, and owner should contact CVFPB for direction.

Suspected trenchline for new pipeline running parallel to levee, 8 feet from toe.

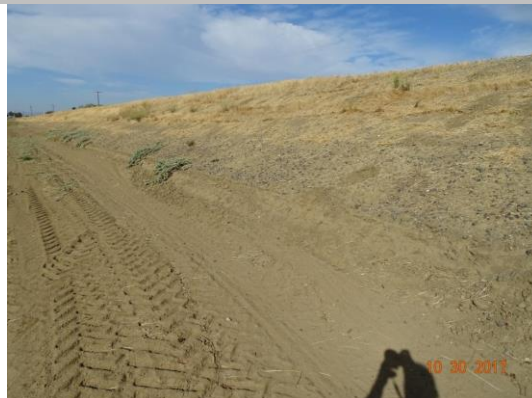
Photo 2 of 2 : FA\_2018\_ST0007\_282\_50\_20180925\_00010.jpg

LM Start	5.31	Rating **	A/W	Issue No.	50 (cont)
LM End	5.39	Issue Type +	En	Location *	WS
Category	Earthen Levee			GPS Latitude/Longitude	
				Start	End
Item	Encroachments			38.518048 °	38.518132 °
				-121.723033 °	-121.724473 °
DWR ID	DWR_ST0007_01_f_2017_50				
Comment Code					
AT : Agricultural tilling					
Inspector Comment					
Access road now present where agricultural tilling was.

Agricultural tilling has encroached into waterside levee toe. Activity should cease and toe should be repaired.

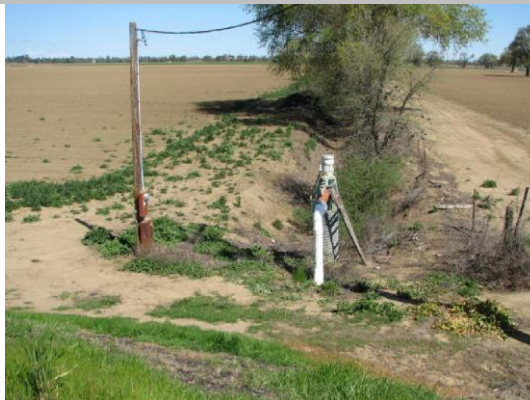
Photo 1 of 3 : UCIP\_FA\_2018\_33367\_60406.jpg

LM Start	5.56	Rating **	M	Issue No.	67
LM End	5.56	Issue Type +	En	Location *	
Category	Supplemental			GPS Latitude/Longitude	
				Start	End
Item	DWR UCIP Field Study			38.518250 °	38.518250 °
				-121.727685 °	-121.727685 °
DWR ID	590				
Comment Code					
Inspector Comment					
FS_ID:33367 DS_ID:590 EP_NO: 14140 Repair Type: Non-Urgent Crossing Status: Found UCIP Comments: Air vent broken off on water side shoulder. Also, no flap gate or other positive closure device on either side of levee. No requirement in permit for applicant to install positive closure device, but it may be necessary if maintenance or upgrade is performed on pipe. FIELD_STRUCT_DESC: 6-inch polyvinyl chloride (PVC) drainage pipe though the levee, 16 feet below the crown. 24-inch standpipe with pump on the landside (LS). Pipe outfall at creek with riprap. FS Date: 4/10/2014 2:35:30 PM

LS pump and pipe

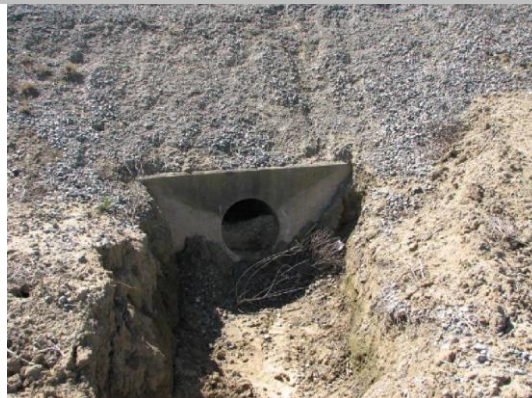
Photo 1 of 2 : UCIP\_FA\_2018\_33364\_60401.jpg

Comment Code					
Inspector Comment					
FS_ID:33364 DS_ID:503 EP_NO: 10252 Repair Type: No Action Needed Crossing Status: Found UCIP Comments: owner of pipe needs to clean out obstruction in pipe. FIELD_STRUCT_DESC: 24-inch corrugated metal drainage pipe through the levee, 12 feet below the crown. Slide gate on the waterside (WS) end. Concrete headwall on the landside (LS) end. (24-inch pipe [HLM 5.86] authorized under Automatic Board Order (ABO) issued as Permit No. 10252, 1974 - John F. Hamel). [Additional Reference(s): DWR Levee Log, 2005. USACE Sacramento O&M Manual 119, December 1952, (Station 108+00 PCT)]. FS Date: 4/10/2014 2:34:15 PM

LS headwall

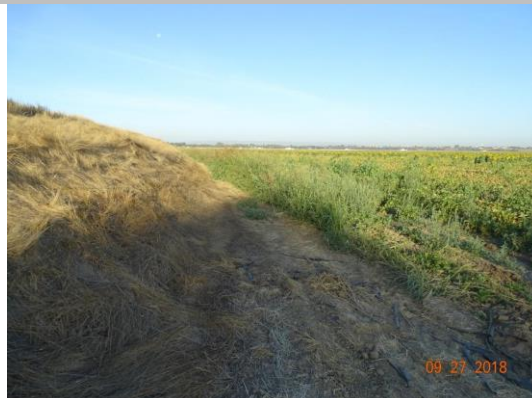
Photo 1 of 3 : FA\_2018\_ST0007\_282\_53\_20180928\_00070.jpg

LM Start	5.84	Rating **	A/W	Issue No.	53
LM End	5.86	Issue Type +	En	Location *	LS
Category	Earthen Levee			GPS Latitude/Longitude	
				Start	End
Item	Encroachments			38.518475 °	38.518478 °
				-121.732822 °	-121.733200 °
DWR ID	DWR_ST0007_01_f_2017_53				
Comment Code					
AT : Agricultural tilling					
Inspector Comment					
Adjacent ag field is currently planted, but not along encroached area. Condition should be monitored.

View looking upstream. Vegetation has encroached on the toe that is covering past evidence of agricultural tilling (September 2018).

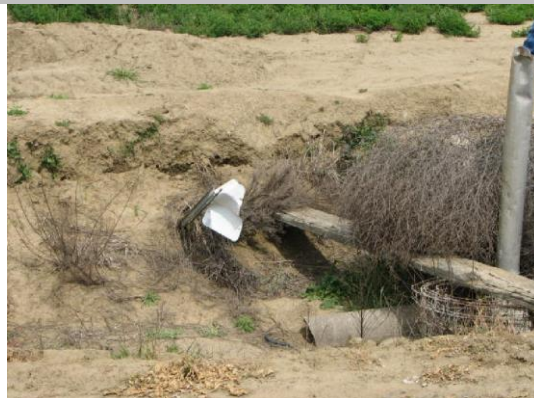
Photo 2 of 2 : UCIP\_FA\_2018\_33347\_60365.jpg

Comment Code						
Inspector Comment						
FS_ID:33347 DS_ID:506 EP_NO: 10820 Repair Type: Non-Urgent Crossing Status: Indicator Found UCIP Comments: Sign on LS bent over and broken. New signs need to be installed locating pipe that indicate a gas line crossing. The broken or missing signs do not indicate gasline, only owner info. Owner is Calpine NRG Scott Vickers 707-249-9211. Supervisor will call phone number and ask for new signs to be installed. FIELD_STRUCT_DESC: 4-inch coated steel gas line through the levee, 2 feet below the crown. (Permit No. 10820, 1975 - Dow Chemical). [Additional Reference(s): DWR Levee Log, 2005]. FS Date: 4/10/2014 2:28:50 PM

LS: sign post bent over in v ditch at toe.

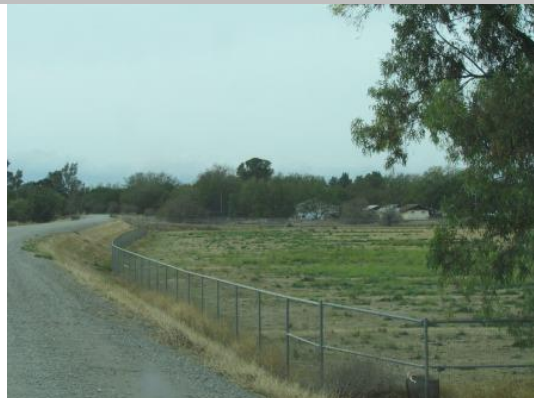
Photo 1 of 2 : FA\_2018\_ST0007\_282\_5\_20180925\_00002.jpg

LM Start	6.63	Rating **	M	Issue No.	5
LM End	6.71	Issue Type +	En	Location *	LS
Category	Earthen Levee			GPS Latitude/Longitude	
				Start	End
Item	Encroachments			38.517746 °	38.517647 °
				-121.747220 °	-121.748679 °
DWR ID	DWR_ST0007_01_s_2012_5				
Comment Code					
FE : Fence					
Inspector Comment					
This fence has been in the area for many years. Levee mile 6.70-6.84 landside within10-foot of easement. No new photo ws taken.

Fence at levee mile 6.76 to 6.84 landside within 10-foot of landward toe.  
Not a new encroachment.

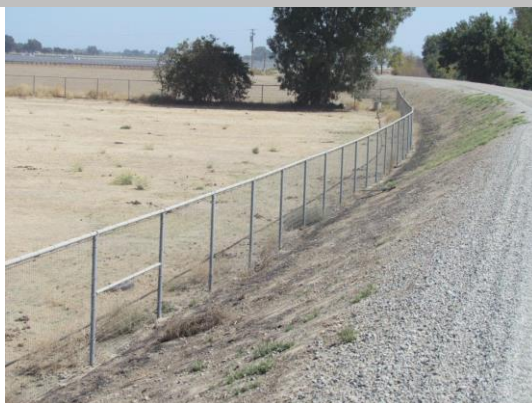
Photo 2 of 2 : FA\_2018\_ST0007\_282\_5\_20180925\_00003.jpg

LM Start	6.63	Rating **	M	Issue No.	5 (cont)	
LM End	6.71	Issue Type +	En	Location *	LS	
Category	Earthen Levee			GPS Latitude/Longitude		
				Start		End
Item	Encroachments			38.517746 °		38.517647 °
				-121.747220 °		-121.748679 °
DWR ID	DWR_ST0007_01_s_2012_5					
Comment Code						
FE : Fence						
Inspector Comment						
This fence has been in the area for many years. Levee mile 6.70-6.84 lanside within10-foot of easement. No new photo ws taken.

Levee mile 6.63-6.71 landside levee toe.

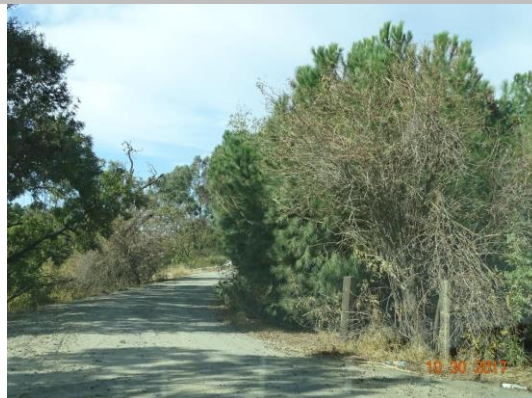
Photo 1 of 1 : FA\_2018\_ST0007\_282\_56\_20180925\_00013.jpg

LM Start	6.89	Rating **	M	Issue No.	56
LM End	6.89	Issue Type +	Ma	Location *	LS
Category	Earthen Levee			GPS Latitude/Longitude	
				Start	End
Item	Trim / Thin Trees			38.517513 °	38.517513 °
				-121.752023 °	-121.752023 °
DWR ID	DWR_ST0007_01_f_2017_56				
Comment Code					
T1 : Trim trees to at least five feet above ground level.					
Inspector Comment

Trees and bushes on landside block visibility and access. Includes elderberries.

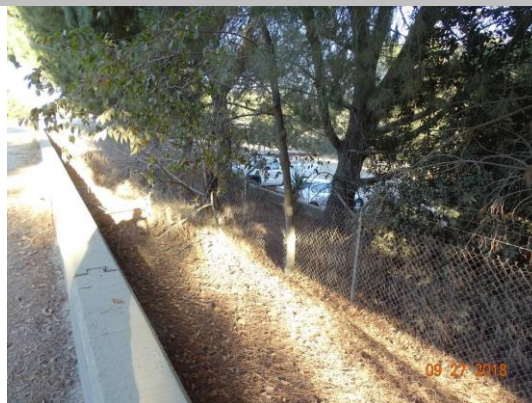
Photo 1 of 1 : FA\_2018\_ST0007\_282\_15\_20180928\_00072.jpg

LM Start	6.90	Rating **	M	Issue No.	15
LM End	6.96	Issue Type +	En	Location *	WS
Category	Earthen Levee			GPS Latitude/Longitude	
				Start	End
Item	Encroachments			38.517594 °	38.517709 °
				-121.752335 °	-121.753241 °
DWR ID	DWR_ST0007_01_s_2013_15				
Comment Code					
FE : Fence					
Inspector Comment					
This fence has no CVFPB Permit.

View of fence (September 2018).

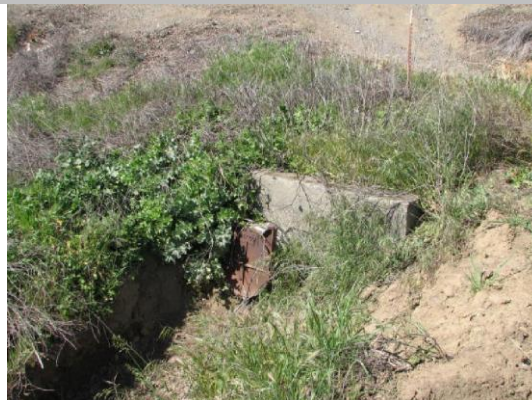
Photo 2 of 2 : UCIP\_FA\_2018\_42952\_60352.jpg

Comment Code					
Inspector Comment					
FS_ID:42952					
DS_ID:512					
EP_NO: 10247					
Repair Type: No Action Needed					
Crossing Status: Found					
UCIP Comments: Debris removed from outlet					
FIELD_STRUCT_DESC: 24-inch drainage pipe of an unknown material through the levee, 12 feet below the crown. Flap gate on the waterside (WS) end. Concrete headwall on the landside (LS) end. (24-inch [HLM 7.36] authorized under Automatic Board Order (ABO) issued as Permit No. 10247, 1974 - University of California, Office of the Regents). [Additional Reference(s): DWR Levee Log, 2005. USACE Sacramento O&M Manual 119, December 1952, (Station 183+97 PCT)].					
FS Date: 4/10/2014 2:27:00 PM

WS Flapgate

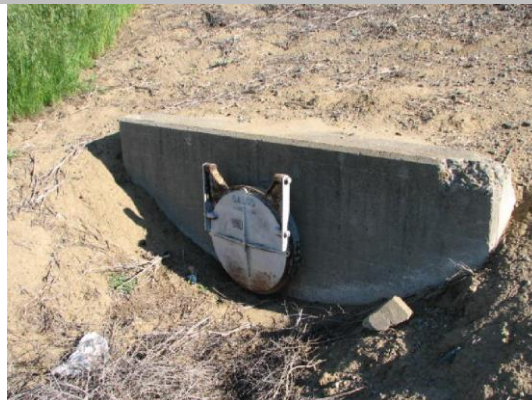
Photo 1 of 2 : UCIP\_FA\_2018\_41353\_60345.jpg

Comment Code					
Inspector Comment					
FS_ID:41353 DS_ID:516 EP_NO: 10260 Repair Type: Non-Urgent Crossing Status: Found UCIP Comments: Pipe is partially obstructed with sedimentation. Owner of pipe may have to clean sediment FIELD_STRUCT_DESC: 24-inch corrugated metal drainage pipe through the levee, 12 feet below the crown. Flap gate on the waterside (WS) end. (24-inch pipe [HLM 7.52] authorized under Automatic Board Order (ABO) issued as Permit No. 10260, 1974 - Southern Pacific Transportation Company). [Additional Reference(s): DWR Levee Log, 2005. USACE Sacramento O&M Manual 119, December 1952, (Station 193+20 PCT)]. FS Date: 4/10/2014 2:25:00 PM

WS Flap Gate and headwall.

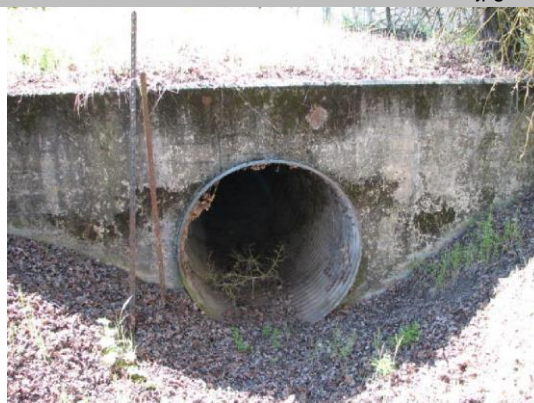
Photo 2 of 3 : UCIP\_FA\_2018\_41129\_60299.jpg

LS headwall and pipe before steel plate was installed over pipe to abandon it.

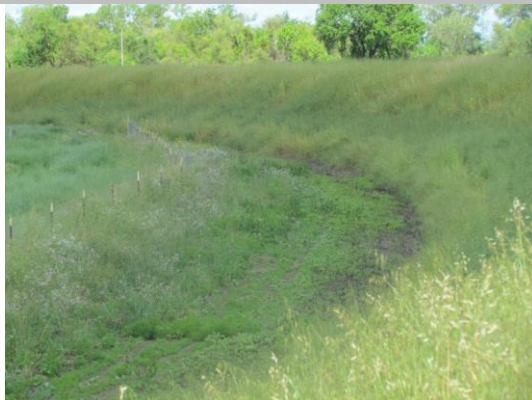
Photo 1 of 1 : FA\_2018\_ST0007\_283\_3\_20180924\_00001.jpg

LM Start	0.18	Rating **	U	Issue No.	3
LM End	0.31	Issue Type +	En	Location *	LS
Category	Earthen Levee			GPS Latitude/Longitude	
				Start	End
Item	Encroachments			38.507155 °	38.509035 °
				-121.682817 °	-121.663488 °
DWR ID	DWR_ST0007_02_s_2012_3				
Comment Code					
DT : Ditch					
Inspector Comment					
This ditch is within the 10-easement

Levee mile 0.18 looking upstream from the landside slope, irrigation ditch along the toe.

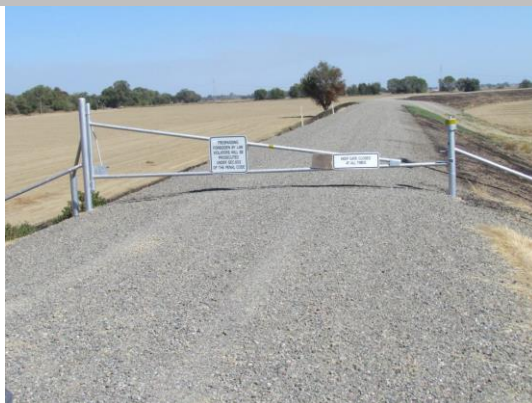
Photo 1 of 4 : FA\_2018\_ST0007\_283\_29\_20180924\_00006.jpg

LM Start	0.55	Rating **	M	Issue No.	29
LM End	0.55	Issue Type +	En	Location *	LS
Category	Earthen Levee			GPS Latitude/Longitude	
				Start	End
Item	Encroachments			38.510249 °	38.510249 °
				-121.667551 °	-121.667551 °
DWR ID	DWR_ST0007_02_s_2013_29				
Comment Code					
FE : Fence					
Inspector Comment					
No CVFPB Permit for this gate. DWR - Sac Maintenance Yard installed this gate a few years ago.

Levee mile 0.55 crown roadway crossing.

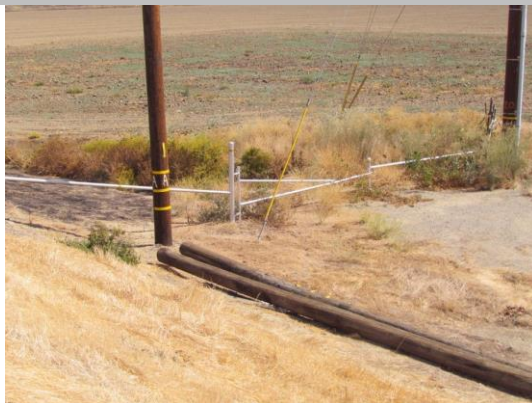
Photo 2 of 4 : FA\_2018\_ST0007\_283\_29\_20180924\_00007.jpg

Levee mile 0.55 landside slope and toe.

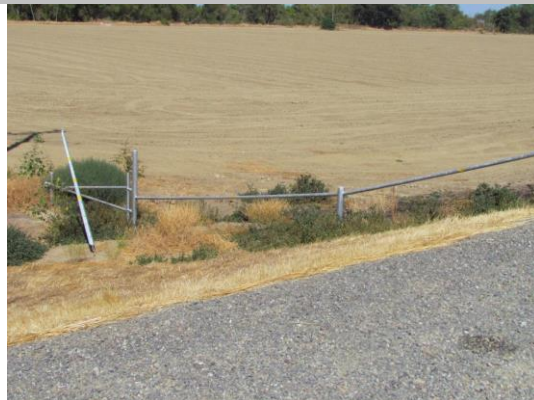
Photo 3 of 4 : FA\_2018\_ST0007\_283\_29\_20180924\_00008.jpg

LM Start	0.55	Rating **	M	Issue No.	29 (cont)	
LM End	0.55	Issue Type +	En	Location *	LS	
Category	Earthen Levee			GPS Latitude/Longitude		
				Start		End
Item	Encroachments			38.510249 °		38.510249 °
				-121.667551 °		-121.667551 °
DWR ID	DWR_ST0007_02_s_2013_29					
Comment Code						
FE : Fence						
Inspector Comment						
No CVFPB Permit for this gate. DWR - Sac Maintenance Yard installed this gate a few years ago.

Levee mile 0.55 waterside slope and toe.

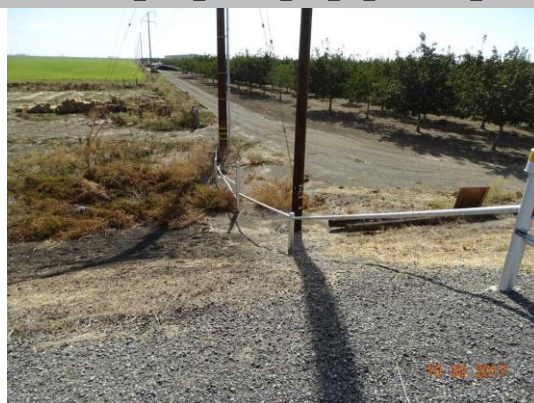
Photo 4 of 4 : FA\_2018\_ST0007\_283\_29\_20180924\_00009.jpg

No CVFPB Permit for this gate. DWR - Sac Maintenance Yard installed this gate a few years ago.

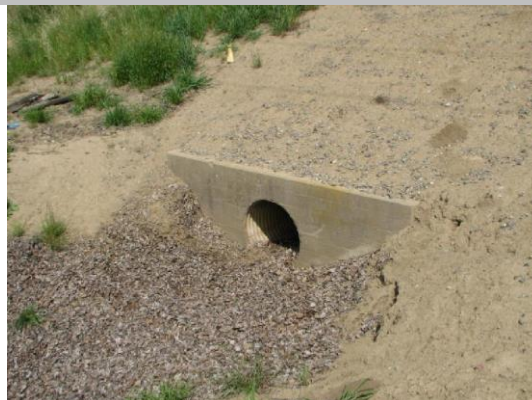
Photo 2 of 3 : UCIP\_FA\_2018\_33407\_60492.jpg

L/S headwall

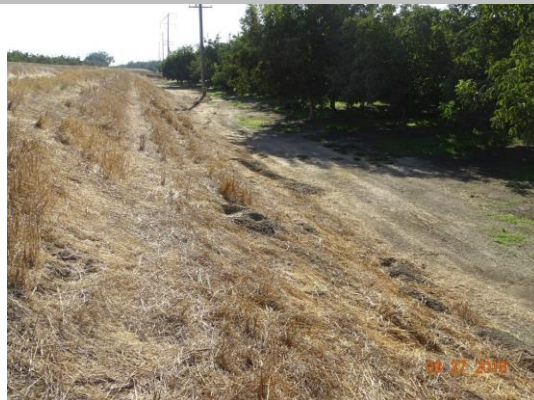
Photo 1 of 3 : FA\_2018\_ST0007\_283\_32\_20180928\_00062.jpg

View looking downstream at multiple animal holes on the levee slope (September 2018).

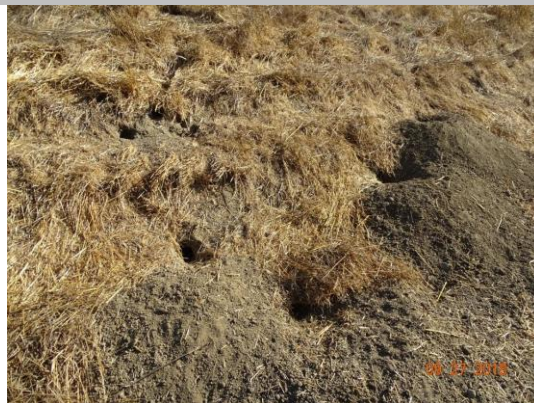
Photo 2 of 3 : FA\_2018\_ST0007\_283\_32\_20180928\_00061.jpg

View of multiple animal holes on the levee slope with fresh dirt in front of the holes (September 2018).

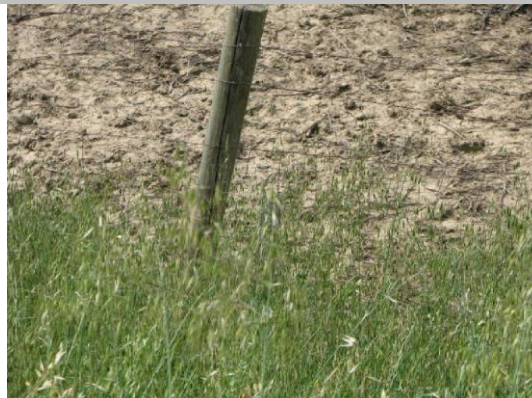
Photo 3 of 3 : UCIP\_FA\_2018\_33400\_60473.jpg

LM Start	1.60	Rating **	M	Issue No.	50 (cont)
LM End	1.60	Issue Type +	En	Location *	
Category	Supplemental			GPS Latitude/Longitude	
				Start	End
Item	DWR UCIP Field Study			38.514250 °	38.514250 °
				-121.685980 °	-121.685980 °
DWR ID	16623				
Comment Code					
Inspector Comment					
FS_ID:33400 DS_ID:16623 EP_NO: 9139 Repair Type: Non-Urgent Crossing Status: Indicator Found UCIP Comments: There are no appropriate gas markers present on levee to indicate pipe location. Markers need to be installed. No danger to the levee FIELD_STRUCT_DESC: 8-inch steel gas line through the levee, 3 feet below the crown, under channel, and through the Unit No. 1 levee. (Permit No. 9139, 1973 - Dow Chemical, U.S.A.). [Additional Reference(s): DWR Levee Log, 2005]. FS Date: 4/10/2014 2:45:48 PM

steel sign marker at LS toe with no sign

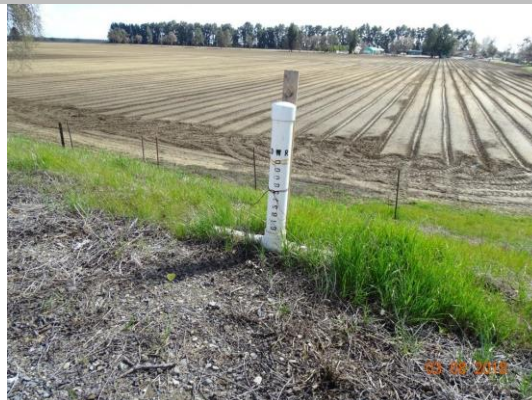
Photo 1 of 1 : FA\_2018\_ST0007\_283\_9\_20180924\_00002.jpg

LM Start	2.00	Rating **	A/W	Issue No.	9
LM End	2.09	Issue Type +	Ma	Location *	LS
Category	Earthen Levee			GPS Latitude/Longitude	
				Start	End
Item	Animal Control			38.515356°	38.515456°
				-121.693168°	-121.694817°
DWR ID	DWR_ST0007_02_s_2013_9				
Comment Code					
A3 : No rodents visible, but rodent burrows visible; need to backfill and compact or grout burrows.					
Inspector Comment					
No indications of recent rodent activity. Bait stations removed. Area should be monitored.

Rodent bait station at LM 2.09.

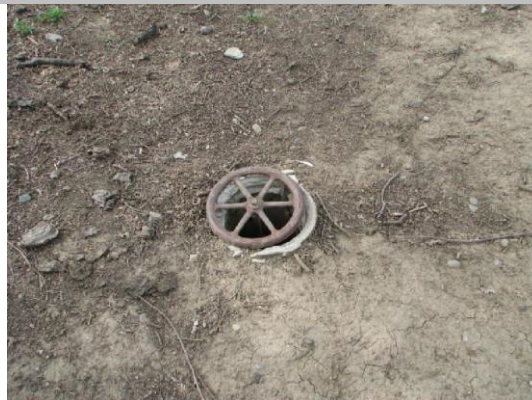
Photo 1 of 3 : UCIP\_FA\_2018\_41072\_60468.jpg

Comment Code						
Inspector Comment						
FS_ID:41072						
DS_ID:16624						
EP_NO: 10268						
Repair Type: Non-Urgent						
Crossing Status: Found						
UCIP Comments: It is apparent that there is an irrigation pipe sleeved through the 25-inch pipe, but size cannot be determined.						
FIELD_STRUCT_DESC: 24-inch corrugated metal irrigation pipe through the levee, 13 feet below the crown. Gate valve on the landside (LS) in 10-inch concrete standpipe. 36-inch standpipe on the waterside (WS) toe. Headwall on the LS toe. (24-inch pipe authorized under Automatic Board Order (ABO) issued as Permit No. 10268, 1974 - Dow Chemical Company). [Additional Reference(s): DWR Levee Log, 2005. USACE Sacramento O&M Manual 119, December 1952, (Station P 265+70)].						
FS Date: 4/10/2014 2:45:00 PM

gate valve on LS toe in 10-inch standpipe

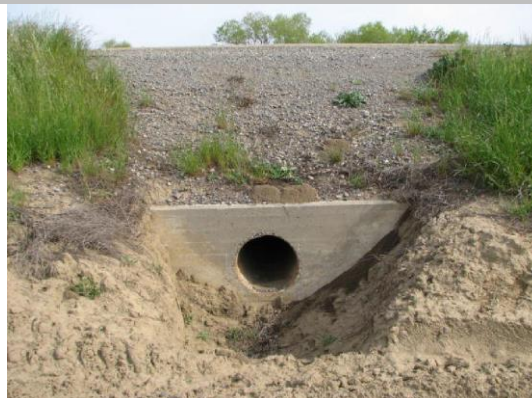
Photo 2 of 2 : UCIP\_FA\_2018\_33393\_60455.jpg

LM Start	3.04	Rating **	A/W	Issue No.	53 (cont)
LM End	3.04	Issue Type +	Ma	Location *	
Category	Supplemental			GPS Latitude/Longitude	
				Start	End
Item	DWR UCIP LMA Responsibility		38.515080 °	38.515080 °	
			-121.711050 °	-121.711050 °	
DWR ID	16626				
Comment Code					
Inspector Comment					
FS_ID:33393 DS_ID:16626 EP_NO: 10277 Repair Type: No Action Needed Crossing Status: Found UCIP Comments: FIELD_STRUCT_DESC: 24-inch corrugated metal drainage pipe through the levee, 9 feet below the crown. Slide gate on the waterside (WS) slope, and headwalls on both sides. (24-inch pipe [HLM 3.11] authorized under Automatic Board Order (ABO) issued as Permit No. 10277, 1974 - Naomi Schoeningh). [Additional Reference(s): DWR Levee Log, 2005. USACE Sacramento O&M Manual 119, December 1952, (Station 50+72 PCT)]. FS Date: 4/10/2014 2:43:31 PM

LS headwall and pipe

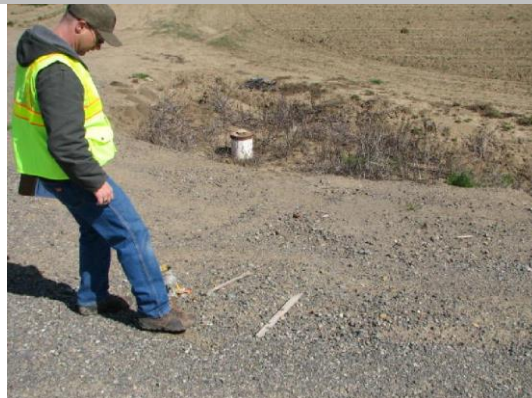
Photo 1 of 1 : UCIP\_FA\_2018\_33392\_60454.jpg

LM Start	3.18	Rating **	M	Issue No.	54
LM End	3.18	Issue Type +	En	Location *	
Category	Supplemental			GPS Latitude/Longitude	
				Start	End
Item	DWR UCIP Field Study			38.515161 °	38.515161 °
				-121.713634 °	-121.713634 °
DWR ID	16627				
Comment Code					
Inspector Comment					
FS_ID:33392 DS_ID:16627 EP_NO: 2273A Repair Type: Non-Urgent Crossing Status: Indicator Found UCIP Comments: WS shoulder air vent looks broken and needs marker FIELD_STRUCT_DESC: 1 of 2: 18-inch coated steel irrigation pipe through the levee, 2 feet below the crown. Pump on well on the landside (LS). 18-inch standpipe on the waterside (WS) toe. Fresno valve on the LS toe, and air vent on the WS shoulder. 36-inch standpipe on the LS. (Permit No. 2273-A, 1980 - William B. Schoeningh). [Additional Reference(s): DWR Levee Log, 2005]. FS Date: 4/10/2014 2:43:17 PM

WS shoulder showing air vent with no sign and 18-inch standpipe at WS toe.

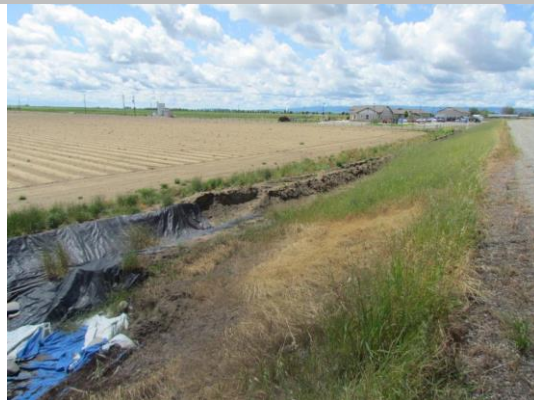
Photo 1 of 1 : FA\_2018\_ST0007\_283\_34\_20180924\_00010.jpg

LM Start	4.97	Rating **	U	Issue No.	34
LM End	5.03	Issue Type +	En	Location *	LS
Category	Earthen Levee			GPS Latitude/Longitude	
				Start	End
Item	Encroachments			38.515462 °	38.515318 °
				-121.746648 °	-121.747705 °
DWR ID	DWR_ST0007_02_f_2016_34				
Comment Code					
DT : Ditch					
Inspector Comment					
There is an Agriculture ditch placed within the 10-easement landward. This ditch has been reported to Enforcement and a NOV is prepared.

Landside levee toe levee mile 4.97-5.00 looking upstream unauthorized agriculture ditch placed within the easement. No permit for this encroachment.

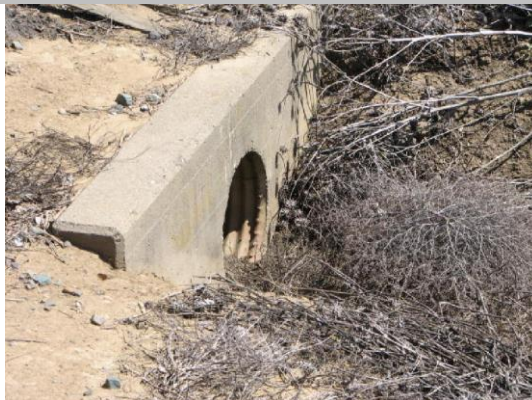
Photo 2 of 2 : UCIP\_FA\_2018\_42953\_60396.jpg

Comment Code						
Inspector Comment						
FS_ID:42953 DS_ID:16639 EP_NO: 10278 Repair Type: No Action Needed Crossing Status: Found UCIP Comments: All material was removed FIELD_STRUCT_DESC: 24-inch corrugated metal drainage pipe through the levee, 15 feet below the crown. Flap gate on waterside (WS) end. Headwall on the landside (LS). (24-inch pipe [HLM 5.99] authorized under Automatic Board Order (ABO) issued as Permit No. 10278, 1974 - Southern Pacific Transportation Company). [Additional Reference(s): DWR Levee Log, 2005. USACE Sacramento O&M Manual 119, December 1952, (Station 208+00 PCT)]. FS Date: 4/10/2014 2:32:00 PM

LS headwall

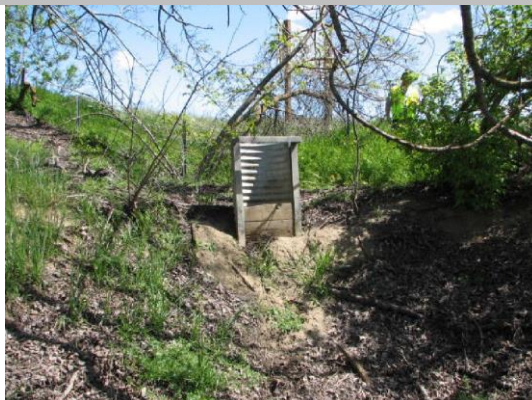
Photo 2 of 3 : UCIP\_FA\_2018\_33348\_60370.jpg

Weir inlet at pond on LS toe.

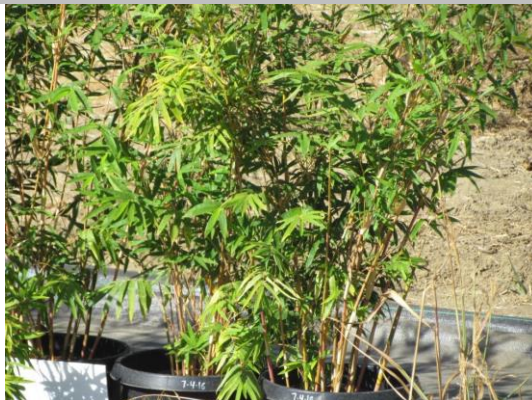
Photo 1 of 2 : FA\_2018\_ST0007\_283\_41\_20180924\_00011.jpg

LM Start	6.53	Rating **	U	Issue No.	41
LM End	6.71	Issue Type +	En	Location *	WS
Category	Earthen Levee			GPS Latitude/Longitude	
				Start	End
Item	Encroachments			38.518497 °	38.519953 °
				-121.774398 °	-121.777080 °
DWR ID	DWR_ST0007_02_s_2017_41				
Comment Code					
TR : Tree or limb					
Inspector Comment					
Bamboo being introduced by landowner on the waterside berm. This is unauthorized.

Putah Creek levee mile 6.63-6.74 unauthorized planting of arundo plants.

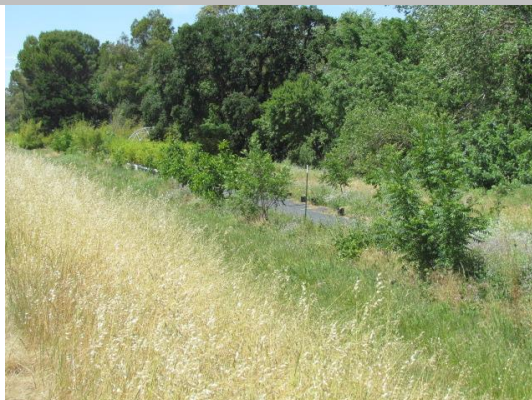
Photo 2 of 2 : FA\_2018\_ST0007\_283\_41\_20180924\_00012.jpg

Levee mile 6.63-6.74 waterward berm landowner has several hundred bamboo planting and other crops.

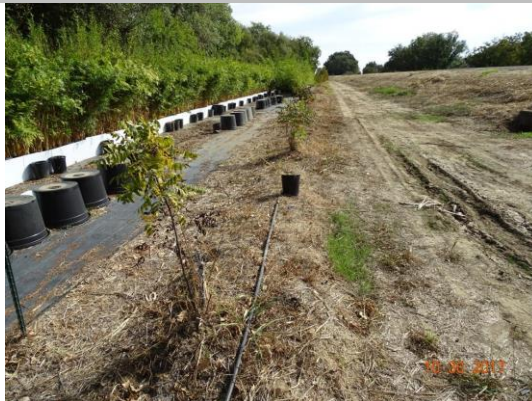
Photo 1 of 1 : FA\_2018\_ST0007\_283\_27\_20180924\_00004.jpg

LM Start	6.54	Rating **	M	Issue No.	27
LM End	6.70	Issue Type +	En	Location *	WS
Category	Earthen Levee			GPS Latitude/Longitude	
				Start	End
Item	Vegetation			38.518590 °	38.519875 °
				-121.774528 °	-121.776912 °
DWR ID	DWR_ST0007_02_f_2017_27				
Comment Code					
V6 : Landscaping					
Inspector Comment					
Trees are still present.

Small nut trees planted on waterside berm should be removed.

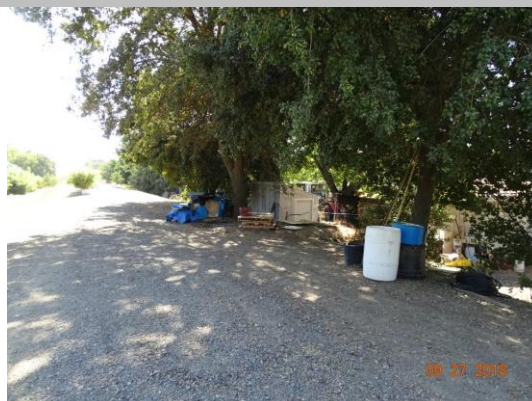
Photo 1 of 1 : FA\_2018\_ST0007\_283\_11\_20180928\_00067.jpg

LM Start	6.56	Rating **	M	Issue No.	11
LM End	6.70	Issue Type +	En	Location *	LS
Category	Earthen Levee			GPS Latitude/Longitude	
				Start	End
Item	Encroachments			38.518760 °	38.519938 °
				-121.774927 °	-121.776952 °
DWR ID	DWR_ST0007_02_s_2012_11				
Comment Code					
MA : Material					
Inspector Comment					
Shipping containers, storage units and other items/debris on the landside easement.

View looking downstream at some of the debris on the land side slope almost to the crown (September 2018).

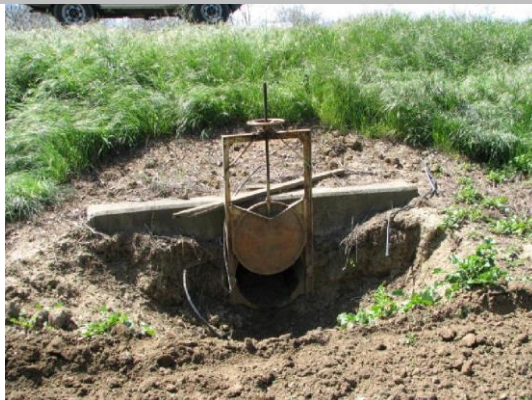
Photo 1 of 2 : UCIP\_FA\_2018\_33346\_60364.jpg

Comment Code						
Inspector Comment						
FS_ID:33346						
DS_ID:16633						
EP_NO: 10276						
Repair Type: Non-Urgent						
Crossing Status: Found						
UCIP Comments: Pipe heavily clogged with soil. Will contact owner of pipe and ask to clean for inspection.						
FIELD_STRUCT_DESC: 24-inch drainage pipe of an unknown material through the levee, 6 feet below the crown. Slide gate on the waterside (WS) end, and headwalls on both ends. (24-inch pipe [HLM 6.83] authorized under Automatic Board Order (ABO) issued as Permit No. 10276, 1974 - Patricia Schlabes). [Additional Reference(s): DWR Levee Log, 2005. USACE Sacramento O&M Manual 119, December 1952, (Station 237+50 ""PCT"")].						
FS Date: 4/10/2014 2:28:29 PM

WS slide gate showing soil plug

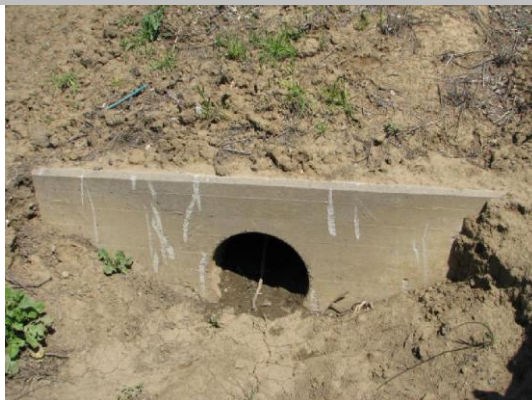
Photo 2 of 2 : UCIP\_FA\_2018\_33346\_60363.jpg

LS headwall showing soil plug

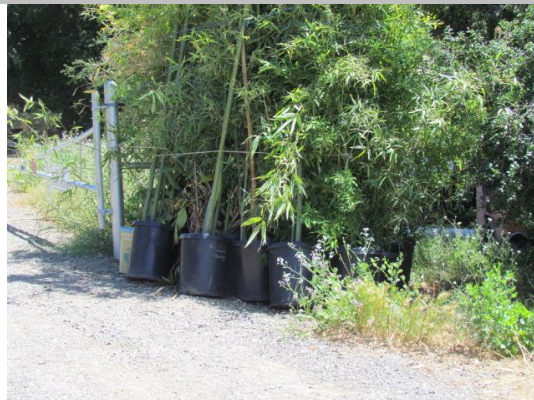
Photo 1 of 1 : FA\_2018\_ST0007\_283\_48\_20180924\_00014.jpg

LM Start	6.70	Rating **	U	Issue No.	48
LM End	6.70	Issue Type +	En	Location *	CR
Category	Earthen Levee			GPS Latitude/Longitude	
				Start	End
Item	Encroachments			38.519927 °	38.519927 °
				-121.777033 °	-121.777033 °
DWR ID	DWR_ST0007_02_s_2017_48				
Comment Code					
TR : Tree or limb					
Inspector Comment					
Remove the unauthorized bamboo plantings from the landside levee section (Fall 2018).

Levee mile 6.70 at the District's gate landowner has placed several bamboo plantings against the gate way landward.

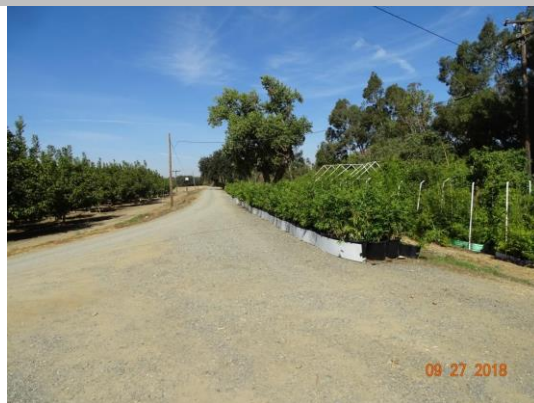
Photo 1 of 1 : FA\_2018\_ST0007\_283\_35\_20180928\_00068.jpg

LM Start	6.71	Rating **	U	Issue No.	35
LM End	6.74	Issue Type +	En	Location *	CR
Category	Earthen Levee			GPS Latitude/Longitude	
				Start	End
Item	Encroachments			38.519980 °	38.520198 °
				-121.777138 °	-121.777535 °
DWR ID	DWR_ST0007_02_f_2018_35				
Comment Code					
TR : Tree or limb					
Inspector Comment					
Remove bamboo pots from waterside crown.

View of bamboo in pots on the crown (September 2018).
